PRIMARY RECORD

* Resource Name or #: 3202 Isla Vista Drive, APN 476-242-10

ISLENAIR HISTORIC DISTRICT
CITY OF SAN DIEGO

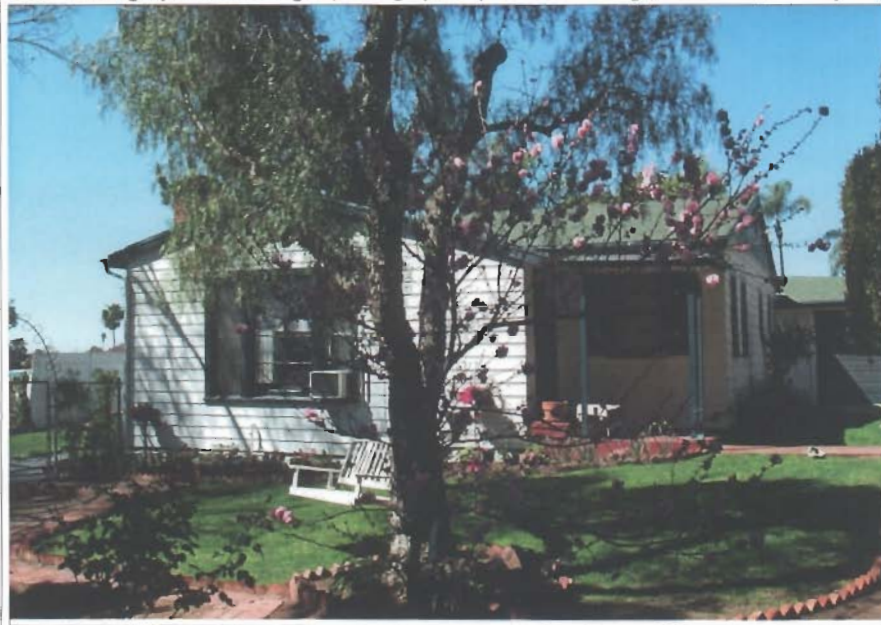
P5a. Photograph or Drawing (Photograph required for buildings, structures, and objects)

* P3a. Description: (Describe resource and its major elements. Include design, materials, condition, alterations, size, setting, and boundaries.)
The house at 3202 Isla Vista Drive was built in 1935 in the Minimal Traditional style and features a medium pitch cross gable roof with composition shingles; a slight eave overhang; and a wood clapboard exterior. The entry porch, which is at grade, is set to the right and features a roof extension supported by a square wood post. The entry door is set perpendicularly to the sidewalk. Fenestration consists of multi-lite and 1-over-1 double hung wood frame and sash windows. Refer to BSOR Section B.6. for modifications and analysis of integrity.

Photo of the primary façade from the public right-of-way.

The house was constructed in 1935 per water and sewer records. Modifications include the replacement of the composition roof with a new composition roof and the addition of a tall hedge, which obscures the house. The house is in good condition and retains a very good degree of integrity.

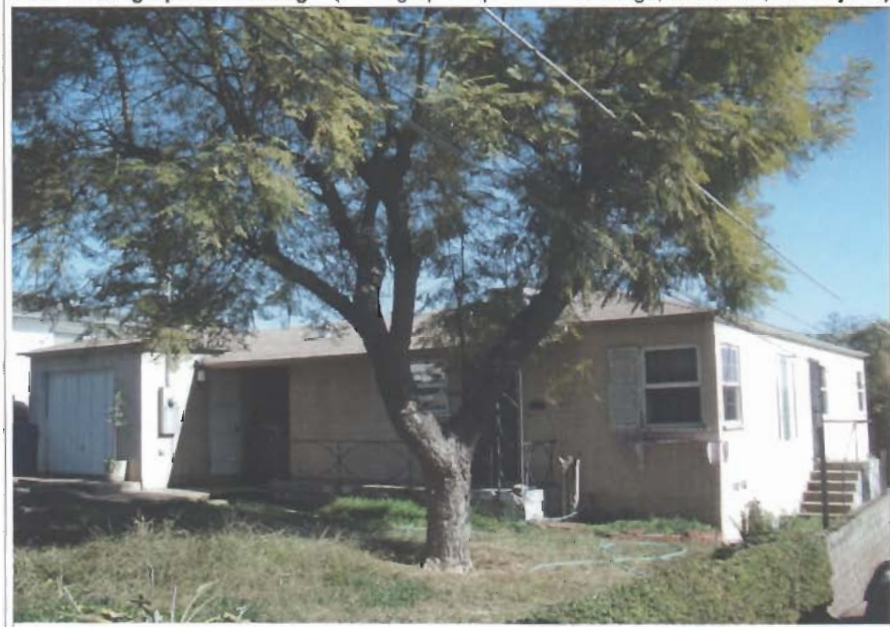
P5a. Photograph or Drawing (Photograph required for buildings, structures, and objects)

* P3a. Description: (Describe resource and its major elements. Include design, materials, condition, alterations, size, setting, and boundaries.)
The house at 3209 Isla Vista Drive was built in 1947 in the Minimal Traditional style with Ranch elements and features a multi-hipped roof with composition shingles; clipped eaves; and a textured stucco exterior. The entry porch, accessed via one concrete step, is set to the right and features a roof extension supported by a decorative wrought iron post. The entry door is set parallel to the sidewalk. The single car garage is set to the left and is connected to the house through a roof over a breezeway. Fenestration consists of 6-over-6 double hung vinyl sash windows in the original wood frames. Refer to BSOR Section B.6. for modifications and analysis of integrity.

Photo of the primary façade from the public right-of-way.

The house was constructed in 1947 per water and sewer records. Modifications include the replacement of the composition roof with a new composition roof, the use of textured stucco, and the replacement of the original wood sash windows with vinyl windows in the original wood frame openings. The house is in fair condition and retains a fair degree of integrity.

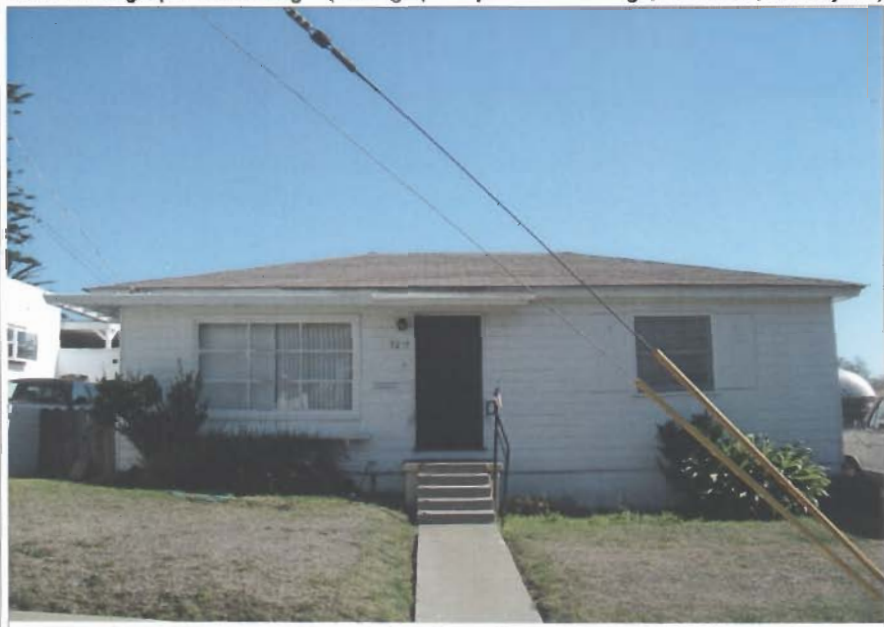
P5a. Photograph or Drawing (Photograph required for buildings, structures, and objects)

* P3a. Description: (Describe resource and its major elements. Include design, materials, condition, alterations, size, setting, and boundaries.)
The house at 3219 Isla Vista Drive was built in 1950 in the Minimal Traditional style and features a hipped roof with composition shingles; clipped eaves; and a wood clapboard exterior. The entry porch, accessed via five concrete steps, is centered on the façade under a slight roof extension. The entry door is set parallel to the sidewalk. Fenestration consists of a 9-lite fixed wood frame picture window and 2-over-2 double hung wood frame and sash windows. Refer to BSOR Section B.6. for modifications and analysis of integrity.

Photo of the primary façade from the public right-of-way.

The house was constructed in 1950 per water and sewer records. Modifications include the replacement of the composition roof with a new composition roof. The house is in good condition and retains a very good degree of integrity.

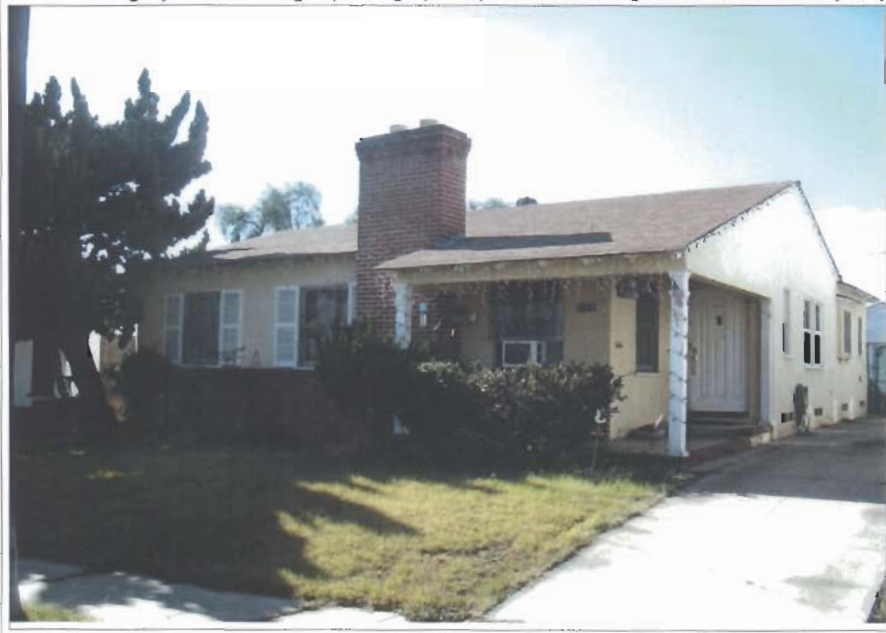
P5a. Photograph or Drawing (Photograph required for buildings, structures, and objects)

* P3a. Description: (Describe resource and its major elements. Include design, materials, condition, alterations, size, setting, and boundaries.)
The house at 3224 Isla Vista Drive was built in 1937 in the Minimal Traditional style and features a side-gable roof with composition shingles; clipped eaves; a stucco exterior; and a wide brick chimney on the east facade. The entry porch, accessed via two concrete steps, is set to the right and features a roof extension supported by a wood post. The entry door is set parallel to the sidewalk. Fenestration consists of 6-over-6 double hung wood frame and sash windows with decorative wood shutters. Refer to BSOR Section B.6. for modifications and analysis of integrity.

Photo of the primary façade from the public right-of-way.

The house was constructed in 1937 per water and sewer records. Modifications include the replacement of the composition roof with a new composition roof. The house is in good condition and retains a very good degree of integrity.

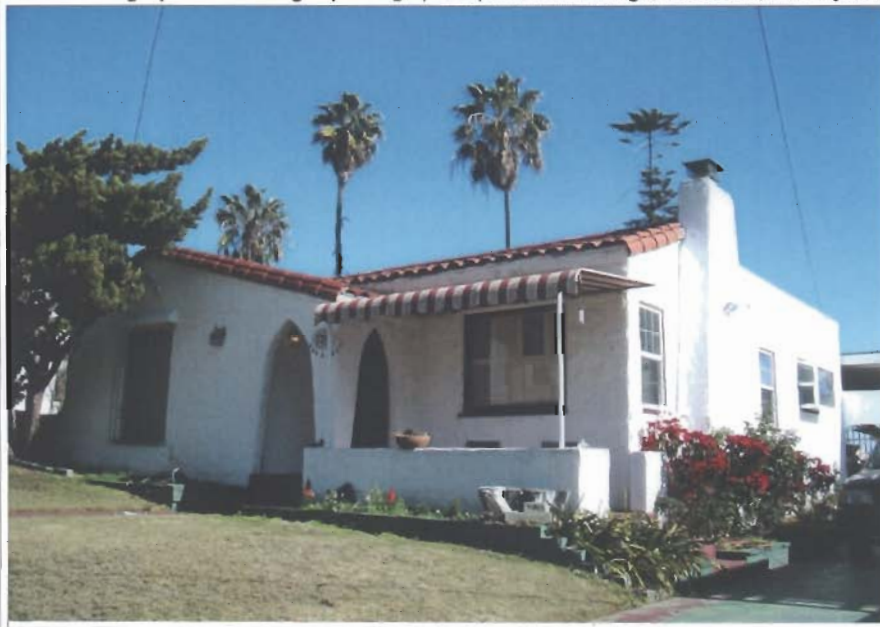
P5a. Photograph or Drawing (Photograph required for buildings, structures, and objects)

* P3a. Description: (Describe resource and its major elements. Include design, materials, condition, alterations, size, setting, and boundaries.)
The house at 3225 Isla Vista Drive was built in 1928 in the Spanish Eclectic style and features a flat roof with a clay tile shed roof along the parapet line and an asymmetrical front-gable bay; clay tile roof vents and drains; a stucco exterior; and a chimney at the south elevation. The entry is set under the longer end of the gable, recessed under a pointed arch opening. The entry door is set parallel to the sidewalk. Fenestration consists of fixed wood frame windows on the main, west façade; and casement and 6-over-6 double hung vinyl frame and sash windows on the south side elevation. Refer to BSOR Section B.6. for modifications and analysis of integrity.

P5b. Description of Photo: (View, date, etc.)
Photo of the primary façade from the public right-of-way.

The house was constructed in 1928 per water and sewer records. Modifications include the replacement of the clay tile roof with new clay tile; the replacement of the original windows along the south side elevation; and the addition of a fabric awning on the main façade. The house is in good condition and retains a good degree of integrity.

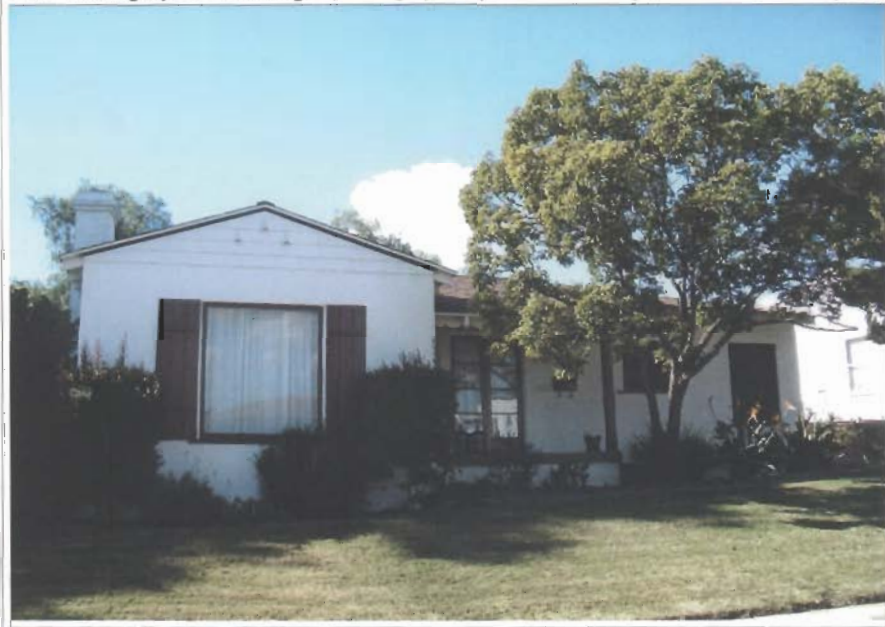
P5a. Photograph or Drawing (Photograph required for buildings, structures, and objects)

* P3a. Description: (Describe resource and its major elements. Include design, materials, condition, alterations, size, setting, and boundaries.)
The house at 3226 Isla Vista Drive was built in 1936 in the Minimal Traditional style and features a medium pitch cross gable roof with composition shingles; clipped eaves; wood clapboard in the gable end; and a stucco exterior. The entry porch, accessed via two concrete steps, is set to the right and features a roof extension supported by a square wood post. The entry door is set perpendicularly to the sidewalk. Fenestration consists of four-lite French doors, and single pane fixed and 1-over-1 double hung wood frame and sash windows. Refer to BSOR Section B.6. for modifications and analysis of integrity.

Photo of the primary façade from the public right-of-way.

The house was constructed in 1936 per water and sewer records. Modifications include the replacement of the composition roof with a new composition roof. The house is in good condition and retains a good degree of integrity.

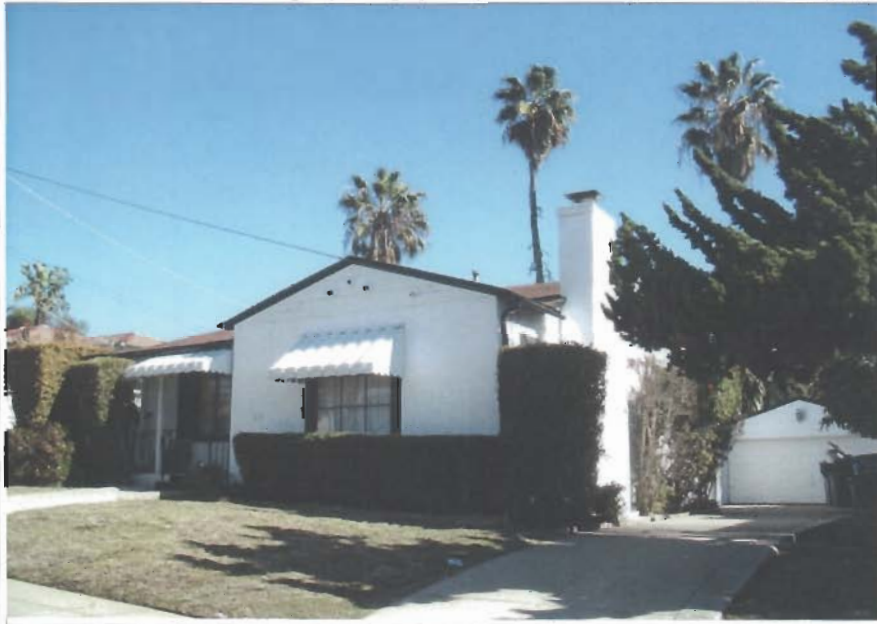
P5a. Photograph or Drawing (Photograph required for buildings, structures, and objects)

Photo of the primary façade from the public right-of-way.

The house was constructed in 1936 per water and sewer records. Modifications include the replacement of the composition roof with a new composition roof and the addition of aluminum awnings. The house is in good condition and retains a good degree of integrity.

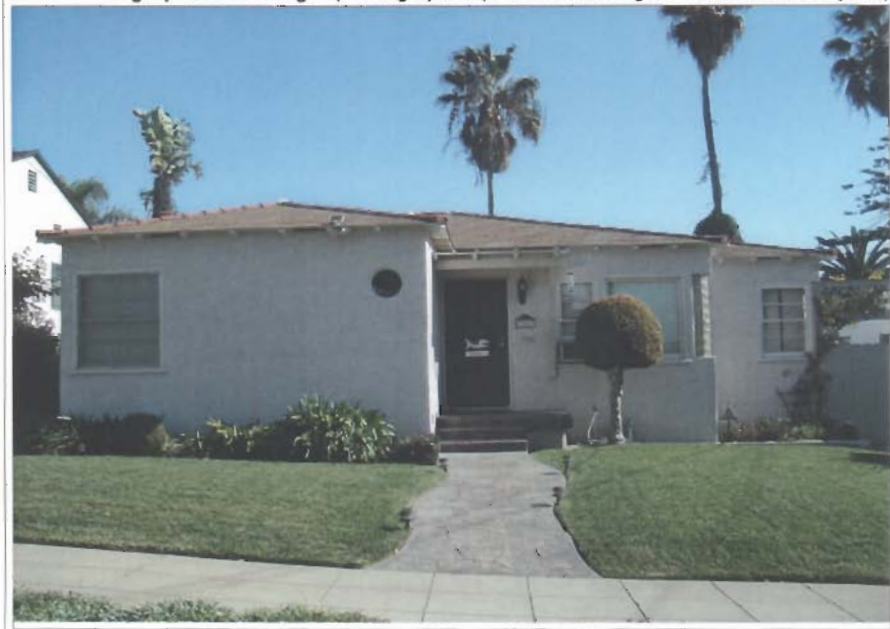
P5a. Photograph or Drawing (Photograph required for buildings, structures, and objects)

Photo of the primary façade from the public right-of-way.

The house was constructed in 1936 per water and sewer records. Modifications include the replacement of the composition roof with a new composition roof and a decorative cement walkway. The house is in good condition and retains a good to fair degree of integrity.

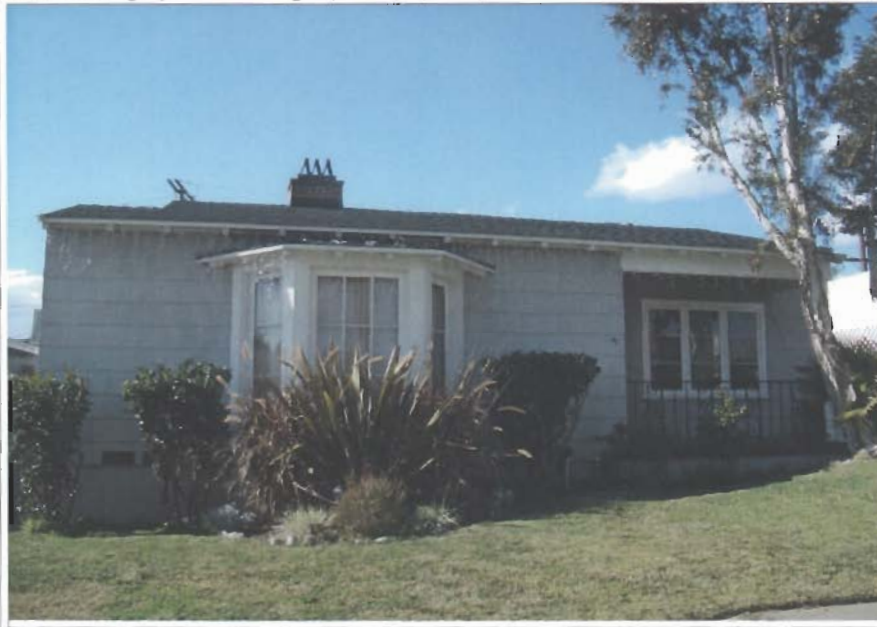
P5a. Photograph or Drawing (Photograph required for buildings, structures, and objects)

* P3a. Description: (Describe resource and its major elements. Include design, materials, condition, alterations, size, setting, and boundaries.)
The house at 3242 Isla Vista Drive was built in 1936 in the Minimal Traditional style with Ranch elements and features a side gable roof with composition shingles; vertical wood siding in the gable end; a slight eave overhang with exposed rafter tails; an asbestos shingle exterior; and a brick chimney at the ridgeline. The entry porch, accessed via two concrete steps, is set to the right and features a roof extension supported by a turned spindle wood post. The entry door is set perpendicularly to the sidewalk. Fenestration consists of multi-lite fixed and casement, as well as 1-over-1 double hung wood frame and sash windows. Refer to BSOR Section B.6. for modifications and analysis of integrity.

P5b. Description of Photo: (View, date, etc.)
Photo of the primary façade from the public right-of-way.

The house was constructed in 1936 per water and sewer records. Modifications include the replacement of the composition roof with a new composition roof and the application of asbestos shingle siding, which appears to have been applied over the original siding, as evidenced by the relationship of the siding to the window frames. The house is in good condition and retains a fair degree of integrity.

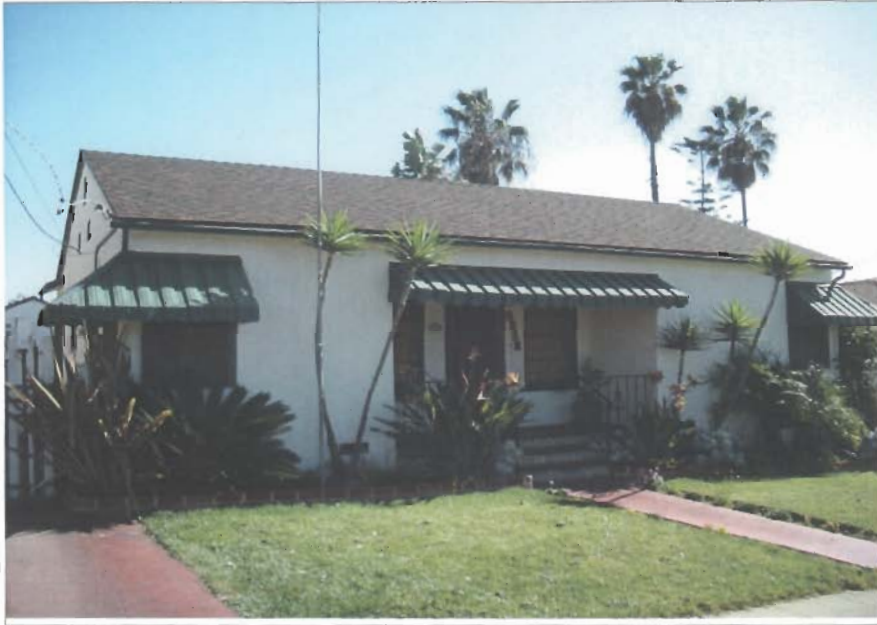
P5a. Photograph or Drawing (Photograph required for buildings, structures, and objects)

* P3a. Description: (Describe resource and its major elements. Include design, materials, condition, alterations, size, setting, and boundaries.)
The house at 3249 Isla Vista Drive was built in 1945 in the Minimal Traditional style and features a side gable roof with composition shingles; horizontal vents in the gable end; clipped eaves; and a smooth stucco exterior. The entry porch, accessed via three concrete steps, is centered and recessed three feet into the façade. The entry door is set parallel to the sidewalk. Fenestration consists of 4-over-4 and 1-over-1 double hung wood frame and sash windows under aluminum awnings. Refer to BSOR Section B.6. for modifications and analysis of integrity.

Photo of the primary façade from the public right-of-way.

The house was constructed in 1945 per water and sewer records. Modifications include the replacement of the composition roof with a new composition roof and the addition of aluminum awnings. The house is in good condition and retains a good degree of integrity.

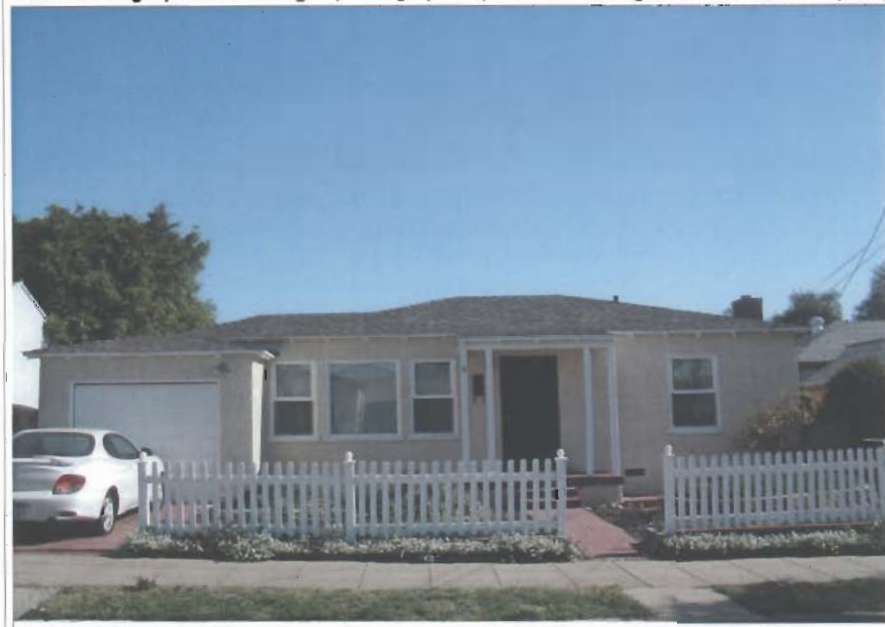
P5a. Photograph or Drawing (Photograph required for buildings, structures, and objects)

* P3a. Description: (Describe resource and its major elements. Include design, materials, condition, alterations, size, setting, and boundaries.)
The house at 3305 Isla Vista Drive was built in 1946 in the Minimal Traditional style and features a hipped roof with composition shingles; a slight eave overhang with rafter tails; and a textured stucco exterior. The entry, accessed via three concrete steps, is set just to the right under a roof projection supported by paired square wood posts. The entry door is set parallel to the sidewalk. Fenestration consists of single pane fixed and 1-over-1 double hung vinyl frame and sash windows. The garage is attached to the house and set forward a few feet. The yard is enclosed by a 3-foot wood picket fence. Refer to BSOR Section B.6. for modifications and analysis of integrity.

Photo of the primary façade from the public right-of-way.

The house was constructed in 1946 per water and sewer records. Modifications include the replacement of the composition roof with a new composition roof; the use of textured stucco; the replacement of the original wood frame windows with vinyl frame windows; and the replacement of the original wood garage door with a roll-up aluminum door. The house is in good condition and retains a fair degree of integrity.

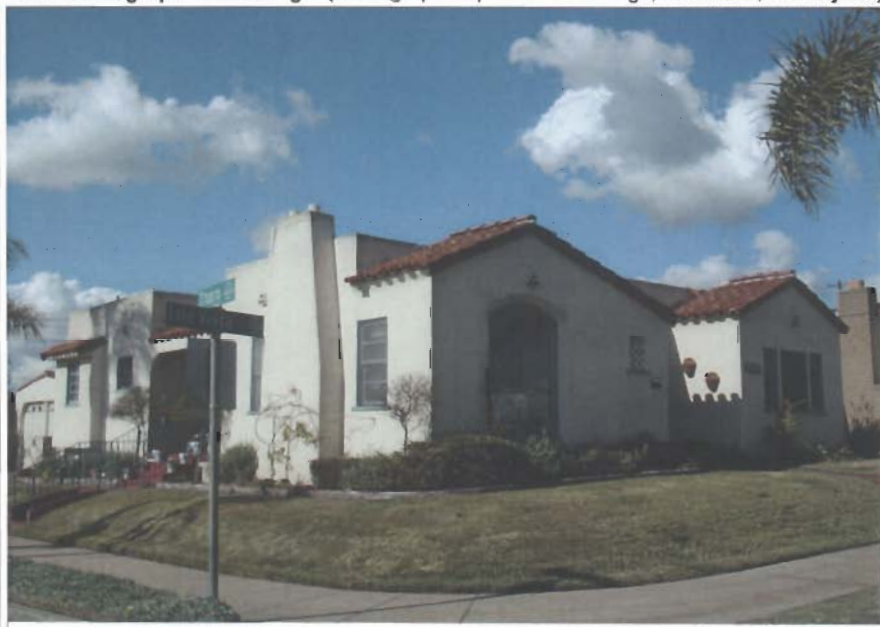
P5a. Photograph or Drawing (Photograph required for buildings, structures, and objects)

* P3a. Description: (Describe resource and its major elements. Include design, materials, condition, alterations, size, setting, and boundaries.)
The house at 3306 Isla Vista Drive was built in 1929 on a corner lot in the Spanish Eclectic style and features a flat roof with a clay tile shed roof along the parapet line and two projecting front-gable bays; clay tile roof vents and drains; a stucco exterior; and a chimney at the south elevation. The main entry, accessed via two concrete steps, is on the Isla Vista street elevation and is centered between the two projecting gables. The entry door is set parallel to the sidewalk. A secondary entry, accessed via 8 concrete steps, fronts onto Thorn Street and is recessed under a low arch opening. Fenestration consists of a large fixed wood frame window on the southern gable of the main façade; and multi-lite casement and 2-over-2 double hung wood frame and sash windows throughout. Refer to BSOR Section B.6. for modifications and analysis of integrity.

Photo of the primary façade from the public right-of-way.

The house was constructed in 1929 per water and sewer records. Modifications include the addition of window screens. The house is in good condition and retains a very good degree of integrity.

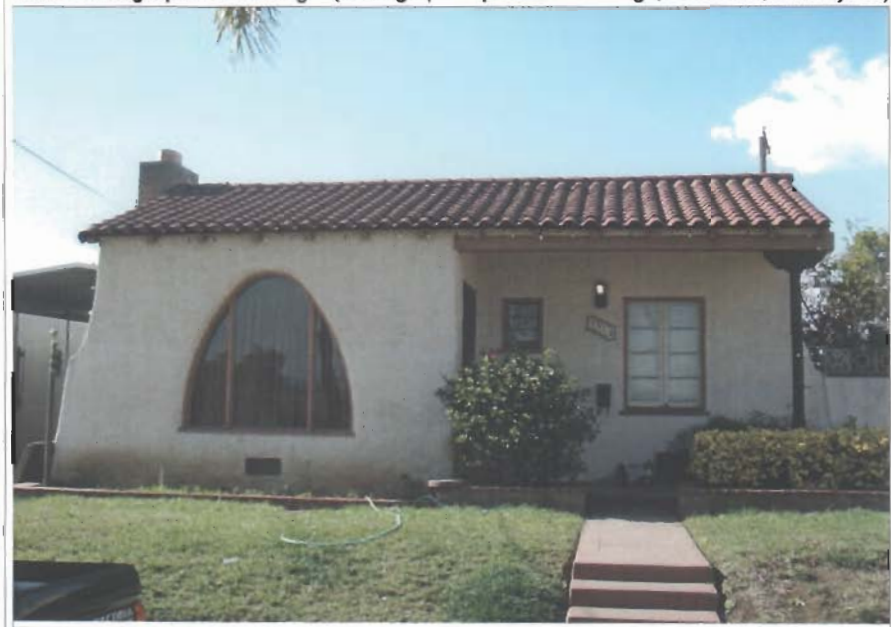
P5a. Photograph or Drawing (Photograph required for buildings, structures, and objects)

* P3a. Description: (Describe resource and its major elements. Include design, materials, condition, alterations, size, setting, and boundaries.)
The house at 3314 Isla Vista Drive was built in 1927 in the Spanish Eclectic style and features a flat roof with a clay tile shed roof along the parapet line; a stucco exterior; and a chimney at the south elevation. The main entry, accessed via five concrete steps, is set to the right under a roof projection supported by a square wood post. The entry door is set perpendicularly to the sidewalk. Fenestration consists of a large arched tri-partite fixed wood frame window; 4-lite casement wood frame and sash windows; and 2-over-2 double hung wood frame and sash windows. Refer to BSOR Section B.6. for modifications and analysis of integrity.

Photo of the primary façade from the public right-of-way.

The house was constructed in 1927 per water and sewer records. Modifications include the replacement of the clay tile roof with a new clay tile roof. The house is in good condition and retains a good degree of integrity.

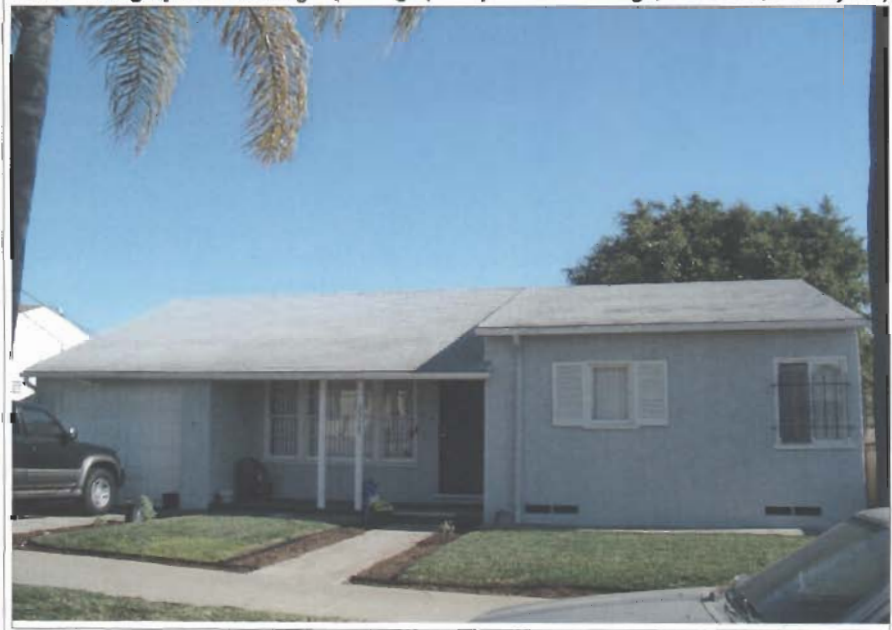
P5a. Photograph or Drawing (Photograph required for buildings, structures, and objects)

* P3a. Description: (Describe resource and its major elements. Include design, materials, condition, alterations, size, setting, and boundaries.)
The house at 3315 Isla Vista Drive was built in 1946 in the Minimal Traditional style and features a side gable roof with composition shingles; a slight eave overhang with rafter tails; and a textured stucco exterior. The entry, accessed via one concrete step, is set just to the left under a roof projection supported by paired square wood posts. The entry door is set parallel to the sidewalk. Fenestration consists of 2-over-2 double hung wood frame and sash windows and one vinyl slider window. The garage is attached to the house and set forward a few feet from the entry façade. Refer to BSOR Section B.6. for modifications and analysis of integrity.

Photo of the primary façade from the public right-of-way.

The house was constructed in 1946 per water and sewer records. Modifications include the replacement of the composition roof with a new composition roof; the use of textured stucco; the replacement of one original wood frame window with a vinyl window; and the replacement of the original wood garage door with a roll-up aluminum door. The house is in good condition and retains a good to fair degree of integrity.

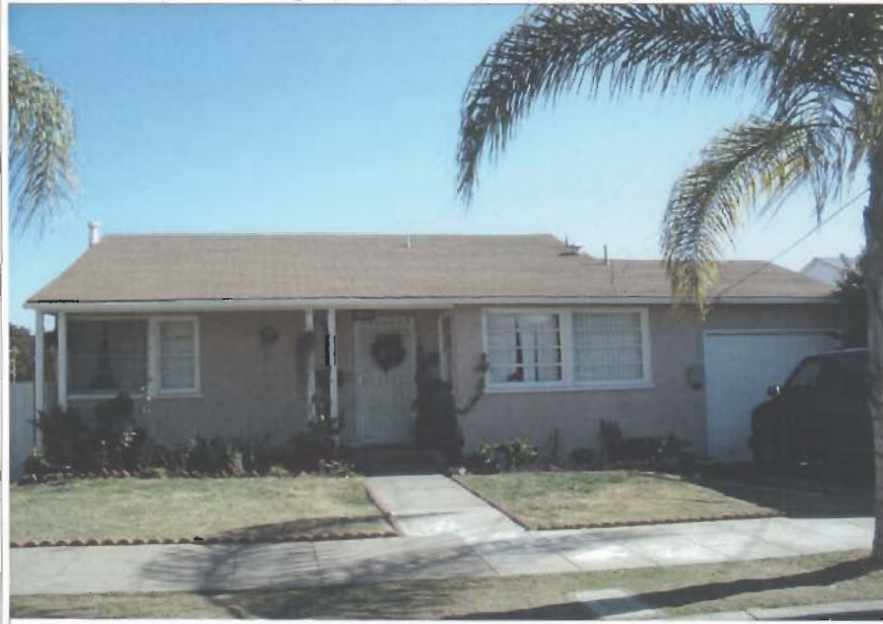
P5a. Photograph or Drawing (Photograph required for buildings, structures, and objects)

* P3a. Description: (Describe resource and its major elements. Include design, materials, condition, alterations, size, setting, and boundaries.)
The house at 3315 Isla Vista Drive was built in 1946 in the Minimal Traditional style and features a side gable roof with composition shingles; a slight eave overhang with rafter tails; and a textured stucco exterior. The entry, accessed via two concrete steps, is set just to the left under a roof projection supported by paired square wood posts. The entry door is set parallel to the sidewalk. Fenestration consists of 2-over-2 double hung wood frame and sash windows. The garage is attached to the house and is flush with the adjacent facade. Refer to BSOR Section B.6. for modifications and analysis of integrity.

Photo of the primary facade from the public right-of-way.

The house was constructed in 1946 per water and sewer records. Modifications include the replacement of the composition roof with a new composition roof and the use of textured stucco. The house is in good condition and retains a good to fair degree of integrity.

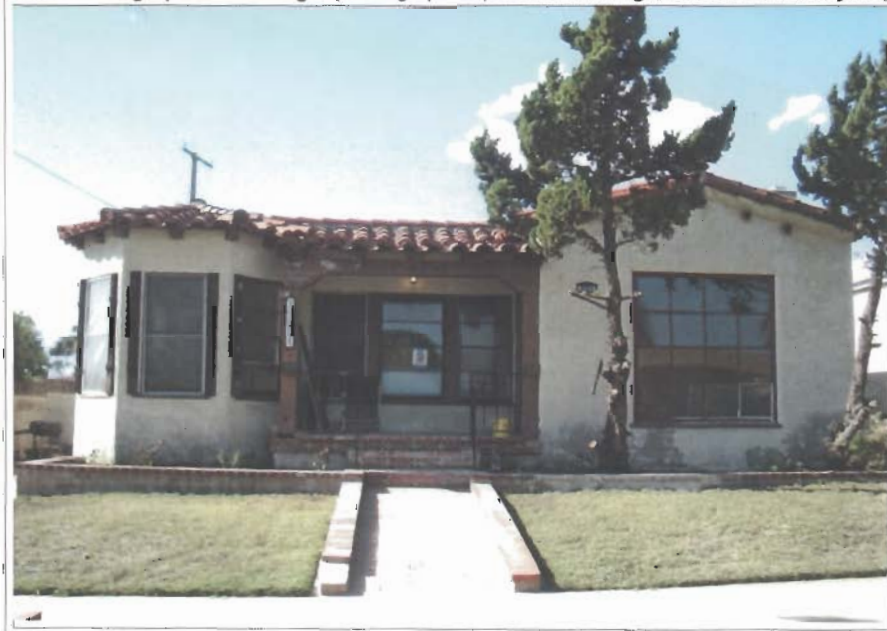
P5a. Photograph or Drawing (Photograph required for buildings, structures, and objects)

Photo of the primary façade from the public right-of-way.

The house was constructed in 1935 per water and sewer records. Modifications include the use of textured stucco and the addition of window screens. The house is in good to fair condition and retains a good to fair degree of integrity.

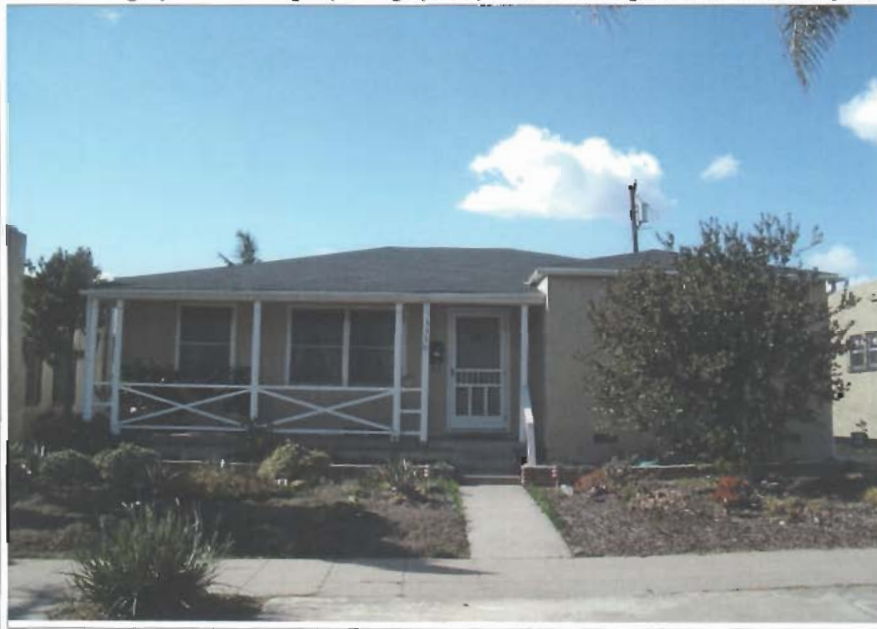
P5a. Photograph or Drawing (Photograph required for buildings, structures, and objects)

* P3a. Description: (Describe resource and its major elements. Include design, materials, condition, alterations, size, setting, and boundaries.)
The house at 3330 Isla Vista Drive was built in 1948 in the Minimal Traditional style and features a hipped roof with composition shingles; a slight eave overhang; and a stucco exterior. The entry, accessed via four concrete steps, is set just to the left of the front bay under a roof projection supported by square wood posts in singles and pairs. The entry door is set parallel to the sidewalk. Fenestration consists of 2-over-2 double hung wood frame and sash windows. Refer to BSOR Section B.6. for modifications and analysis of integrity.

Photo of the primary façade from the public right-of-way.
